# Motorola Moto X 2nd Generation Rear Camera Replacement

Written By: Sophia

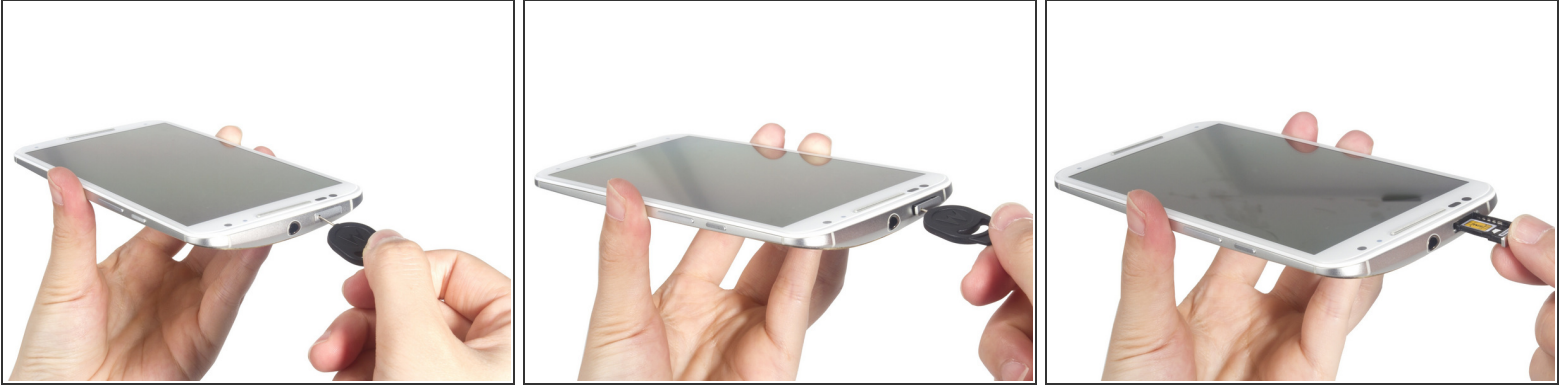
## Step 1 — Rear Camera

- Remove SIM card tray.

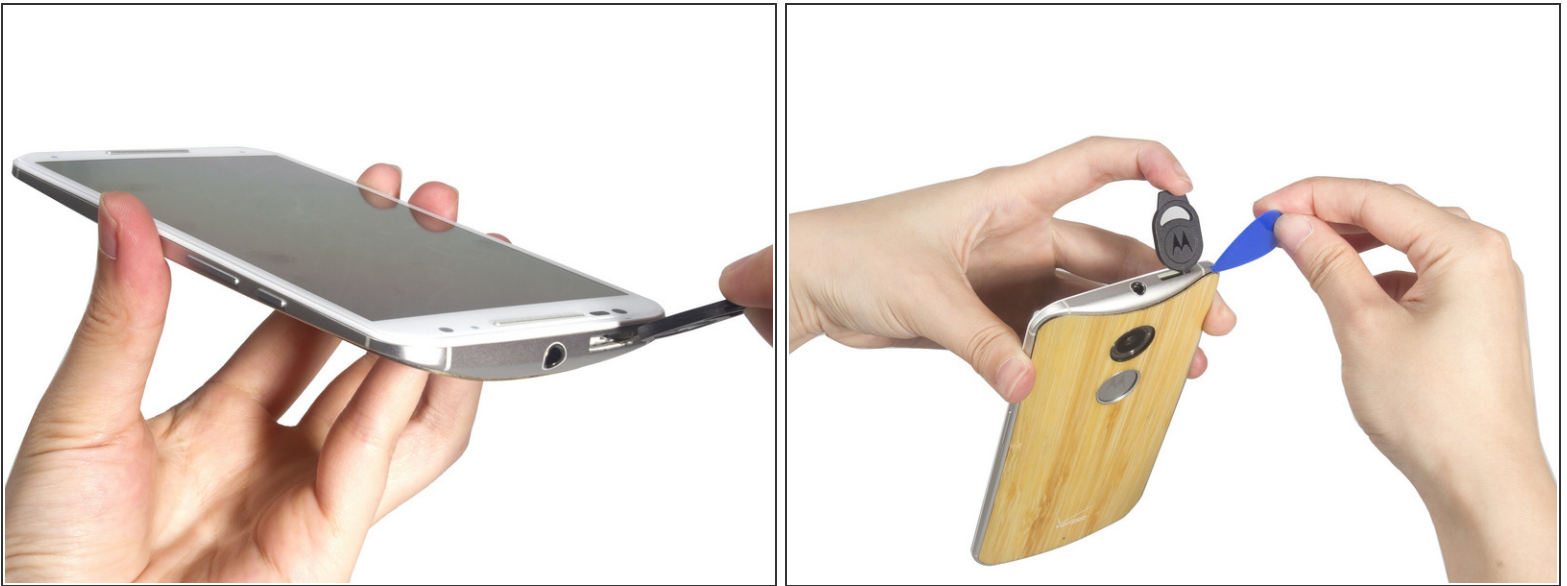
## Step 2

- Push the eject pin to open a gap and place a guitar pick into the gap.

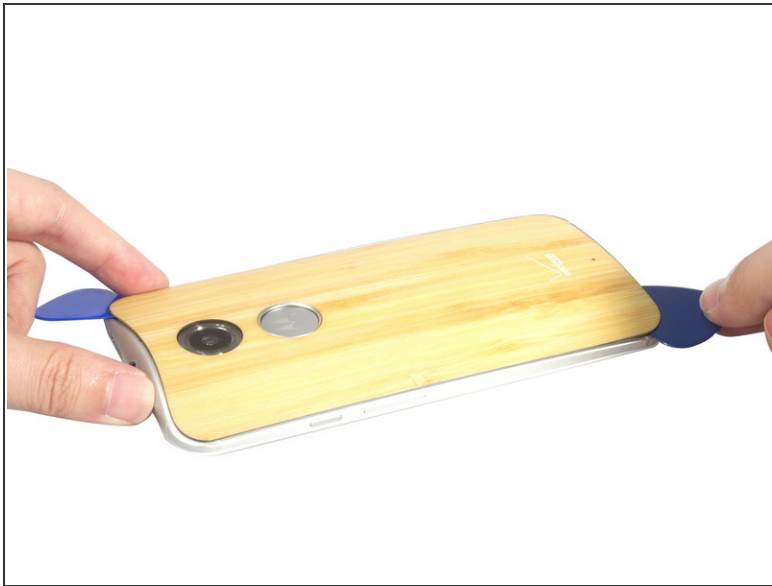
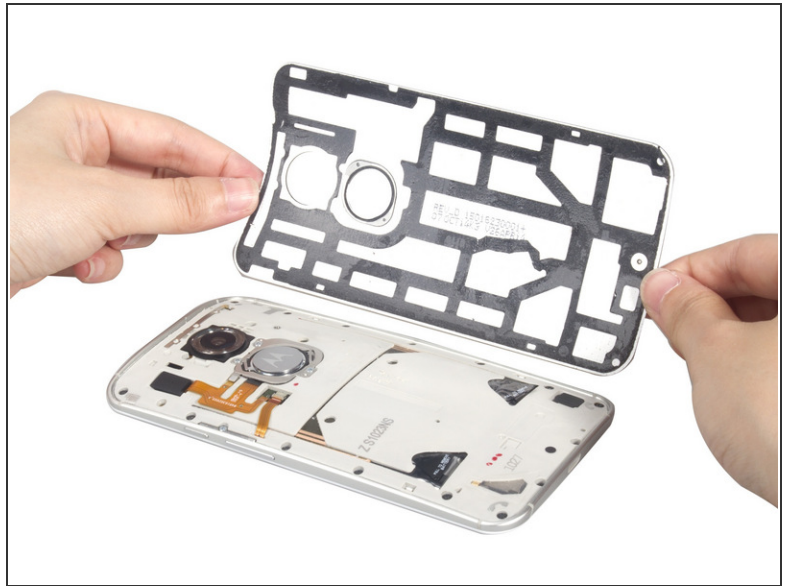
## Step 3

- Slide the guitar pick to cut the adhesive sticker and peel off the back cover.

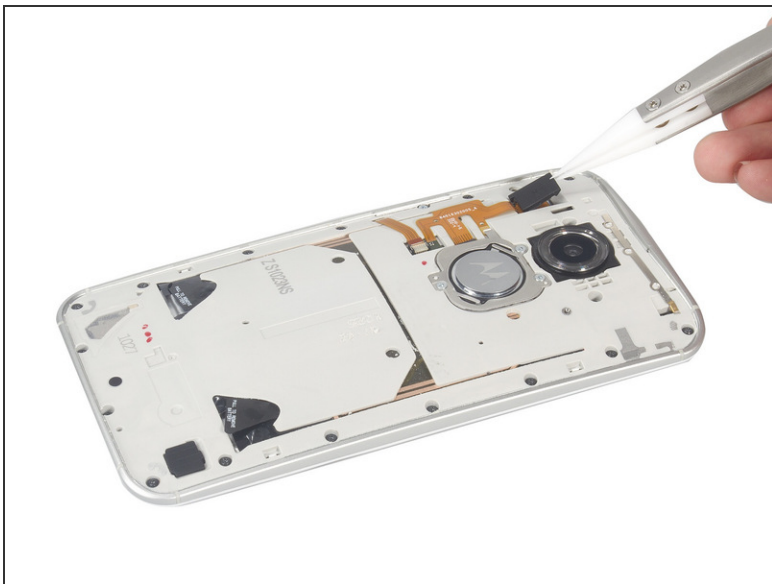
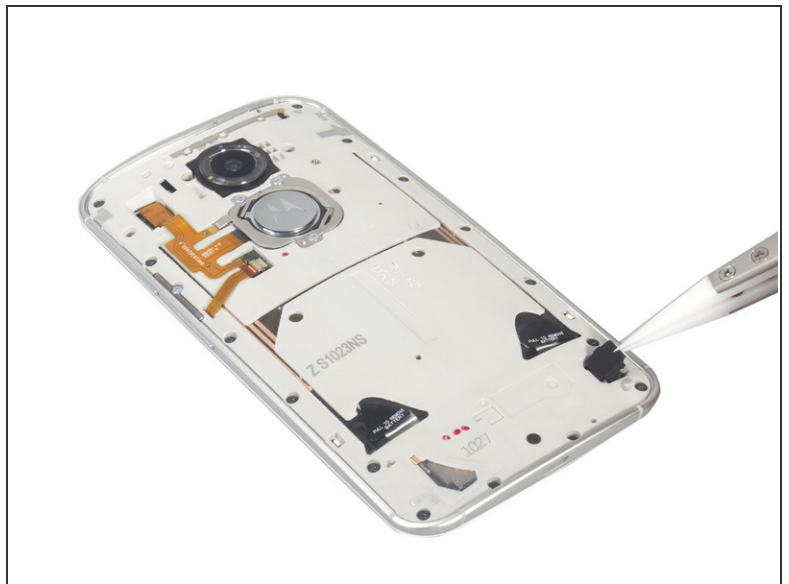
## Step 4

- Remove two pieces rubber cover which protecting the flex connectors.

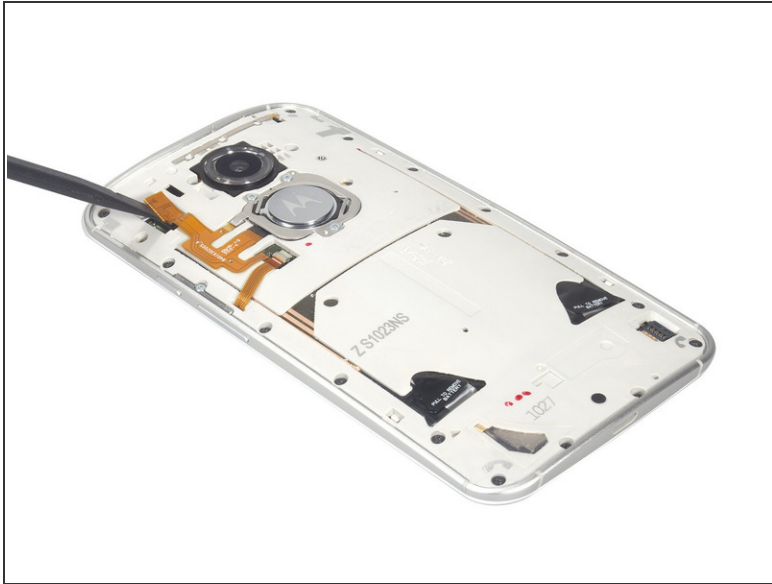
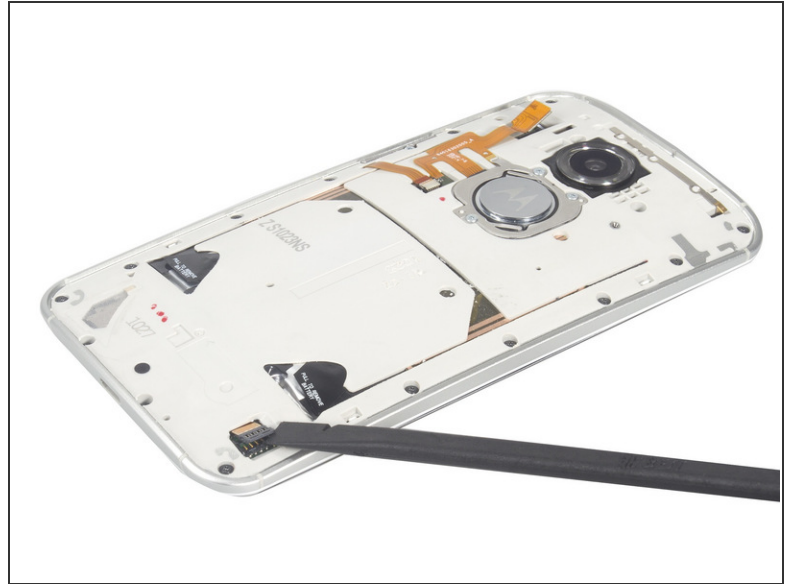
## Step 5

- Release the power button connecting flex connector and battery connector carefully.

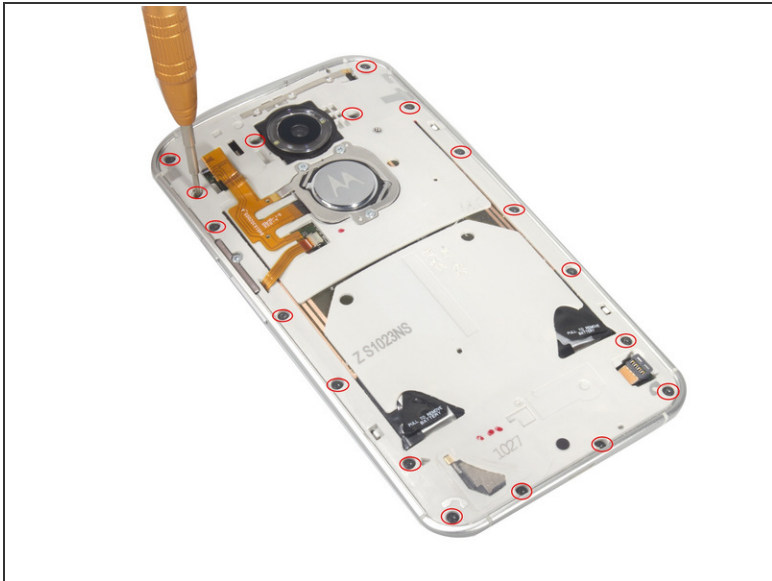
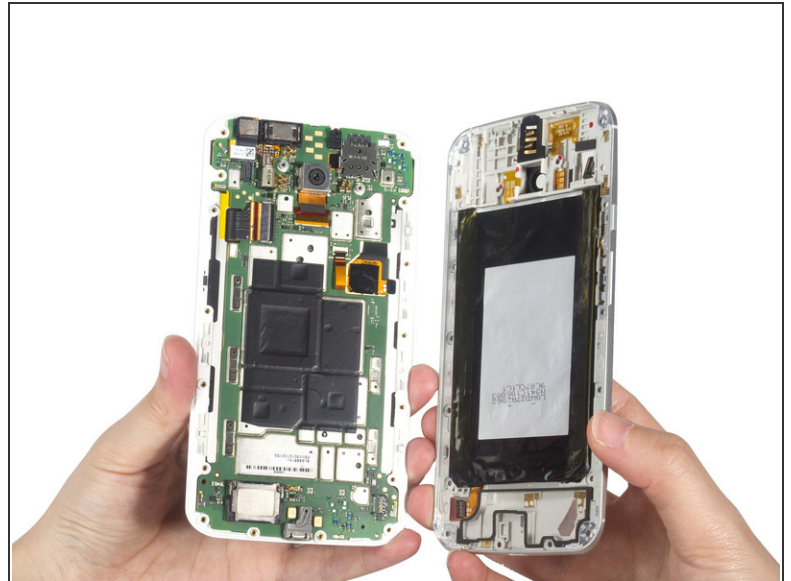
## Step 6

- Twist off all 18 black torx screws and separate the middle housing from front assembly.

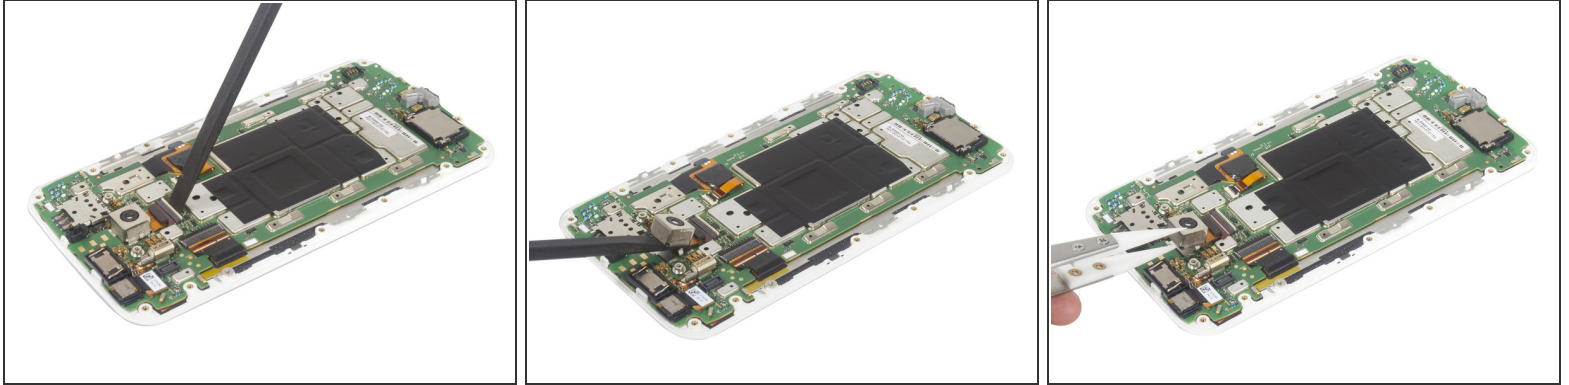
## Step 7

- Release rear camera connector and remove it easily.

To reassemble your device, follow these instructions in reverse order.
